Arborist Report –John and Julie Jones  
\*\*Neighbor's Live Oak\*\*

Arborist Report for John and Julie Jones –  
\*\*Neighbor's Southern Live Oak\*\*

## Arborist Report for John & Julie Jones

**\*\*Neighbor's Southern Live Oak\*\***

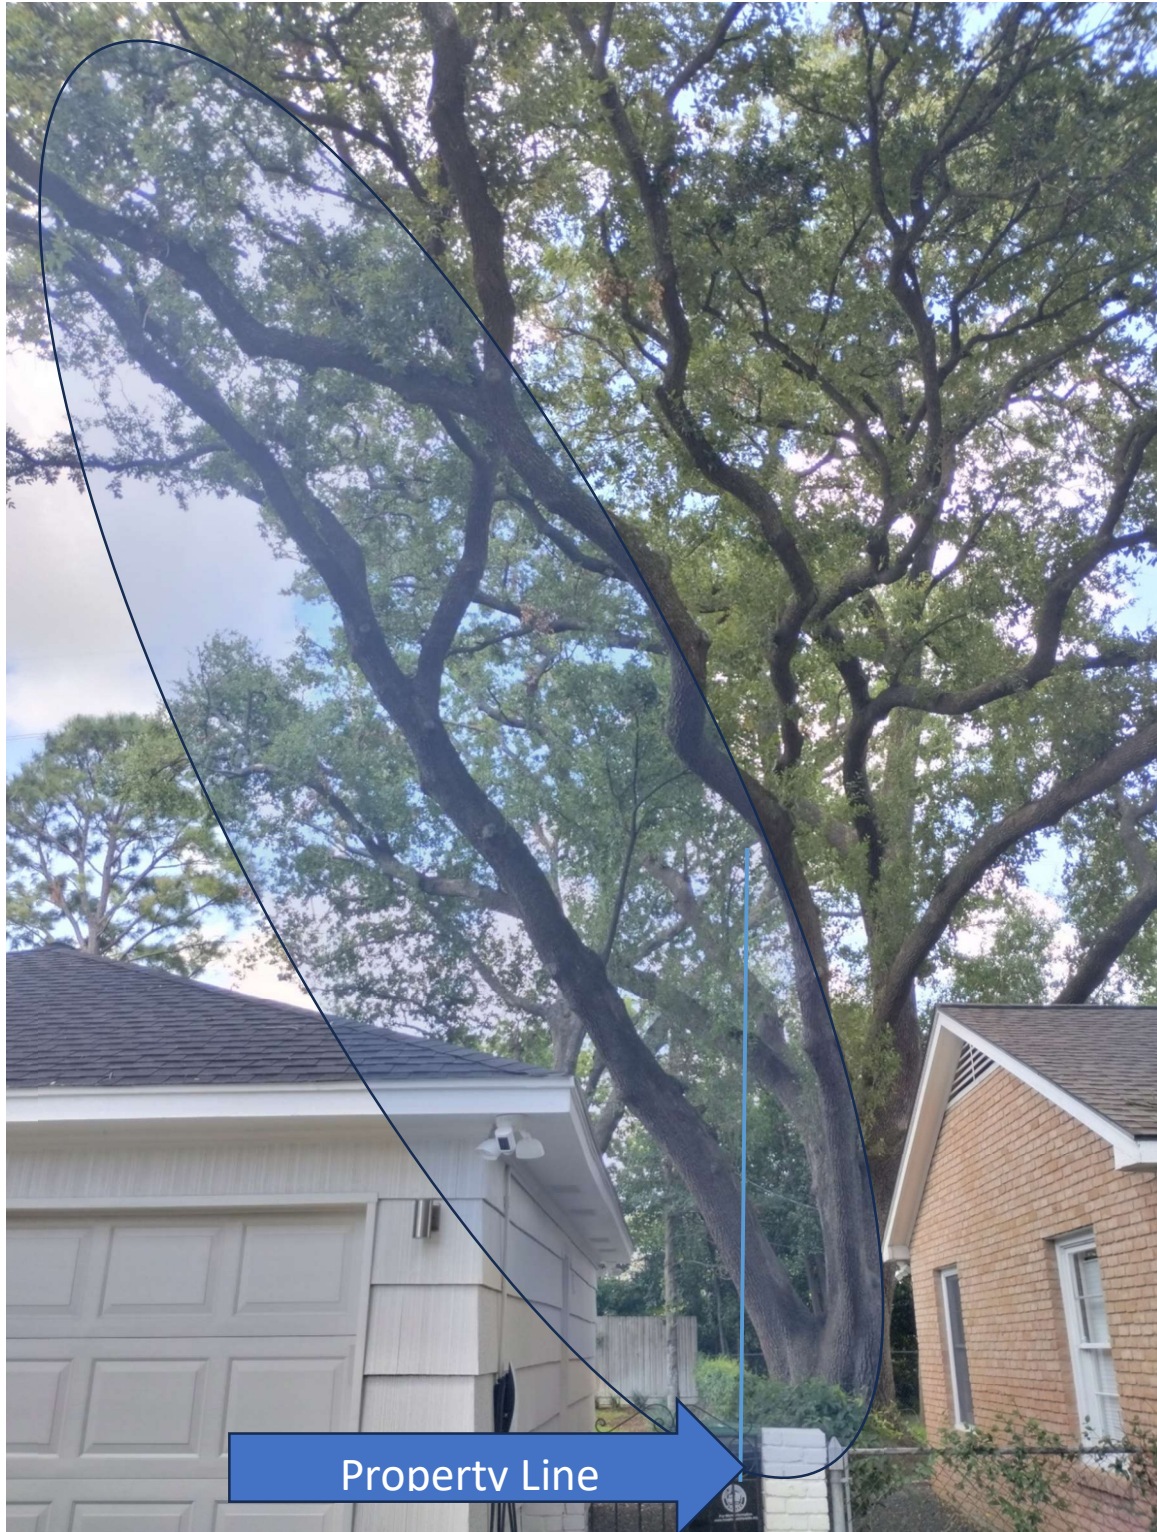
The Southern Live Oak (*Quercus virginiana*) in question is a mature specimen with a large canopy. A significant limb extends towards the southeast, overhanging Mr. and Mrs. Jones' house. The tree exhibits signs of stress, including a notable decay point on the compression side of the limb, stemming from an old pruning wound on the neighbor's property. The leaves also showed some signs of stress, and the canopy was over pruned during the last pruning cycle, causing a large quantity of epicormic sprouts to grow on the top side of the limb. The canopy of the limb in question overhanging the Jones' home is slightly thinning. The canopy has a slight separation in the upper canopy, indicating a potential imbalance between the limb over Mr. and Mrs. Durbin's house and the rest of the canopy. There is a cavity at the base of the limb which may further impact its structural integrity.

*Figure 1 - Tree and Primary Limb in question overhanging Mr. and Mrs. Jones' Home*

1. Obtain explicit permission from the neighbor's attorney or the neighbor directly to access the property and perform the necessary tree care.
2. Reduce the branch tip weight by 20-25% through subordinate and/or reduction pruning techniques to balance the canopy and reduce physical stress on the overextended limb.

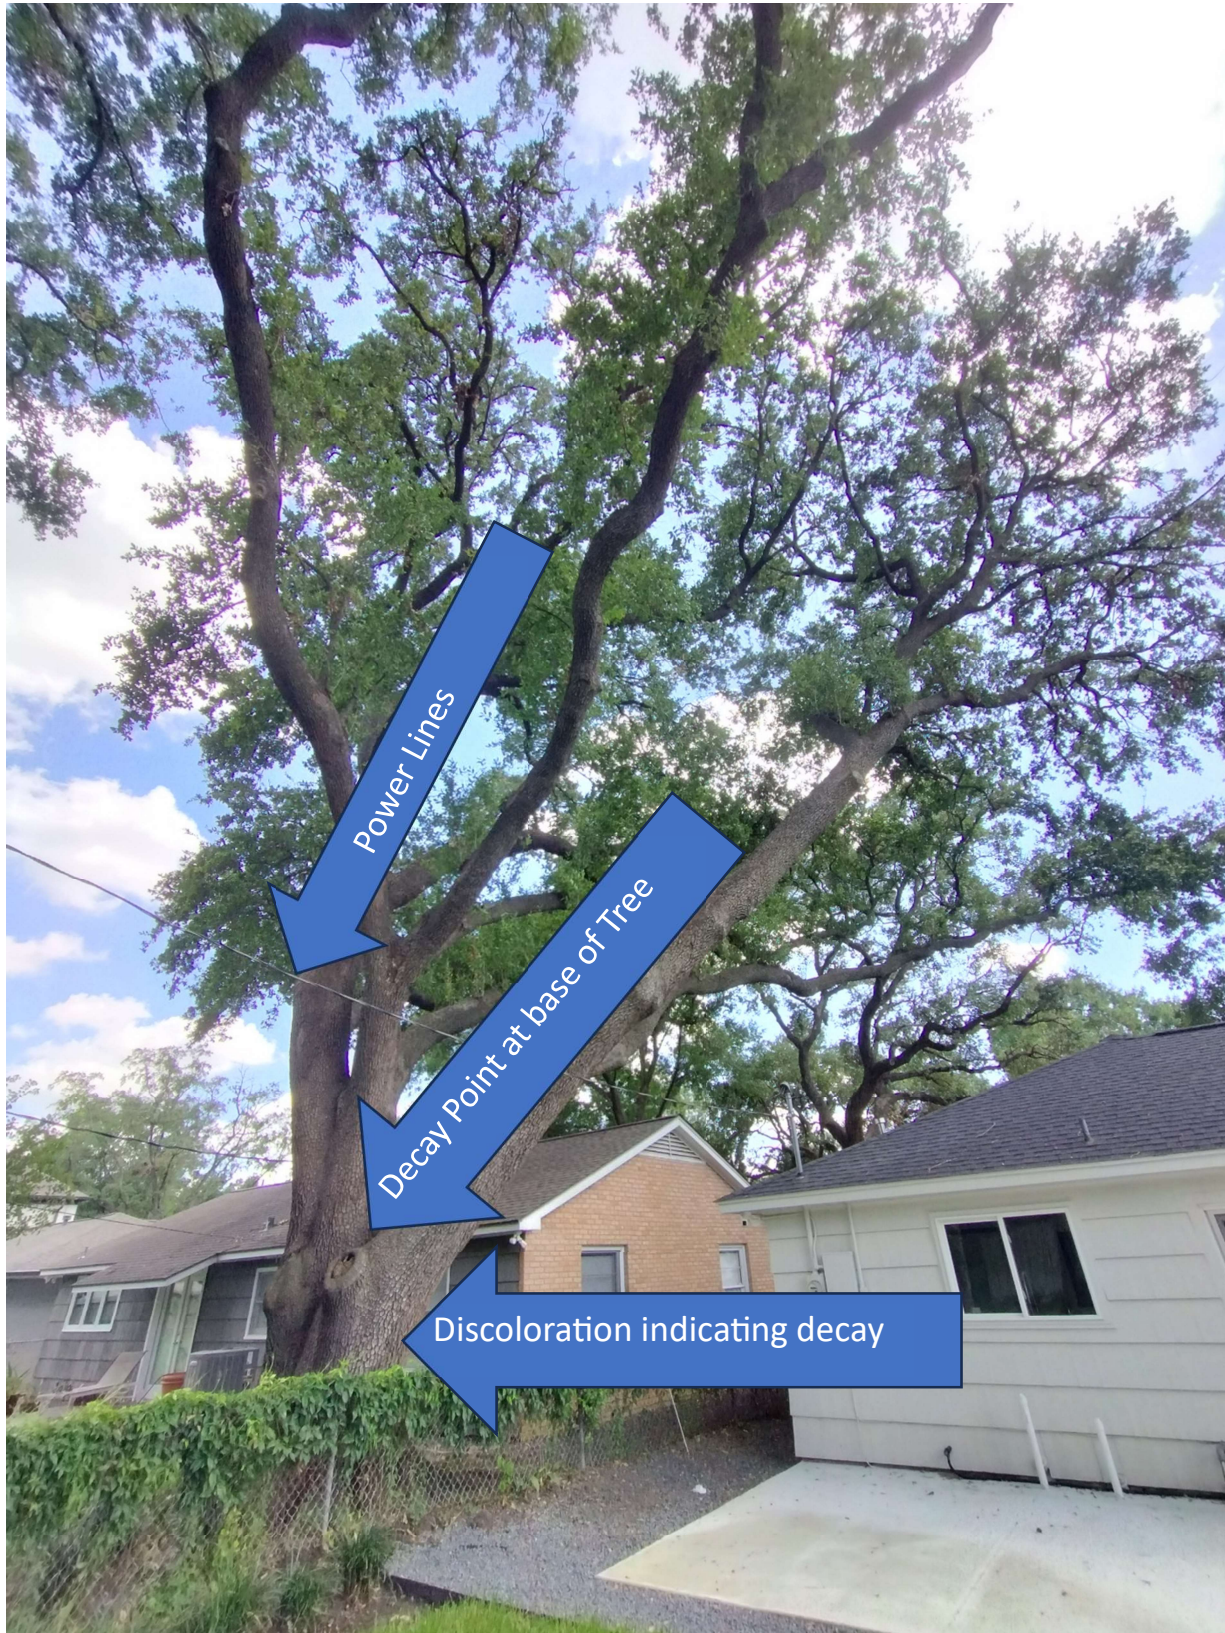
Figure 2 - Full Canopy of Neighbor's tree with Limb overhanging powerline house drop and large portion of house (fisheye lense)

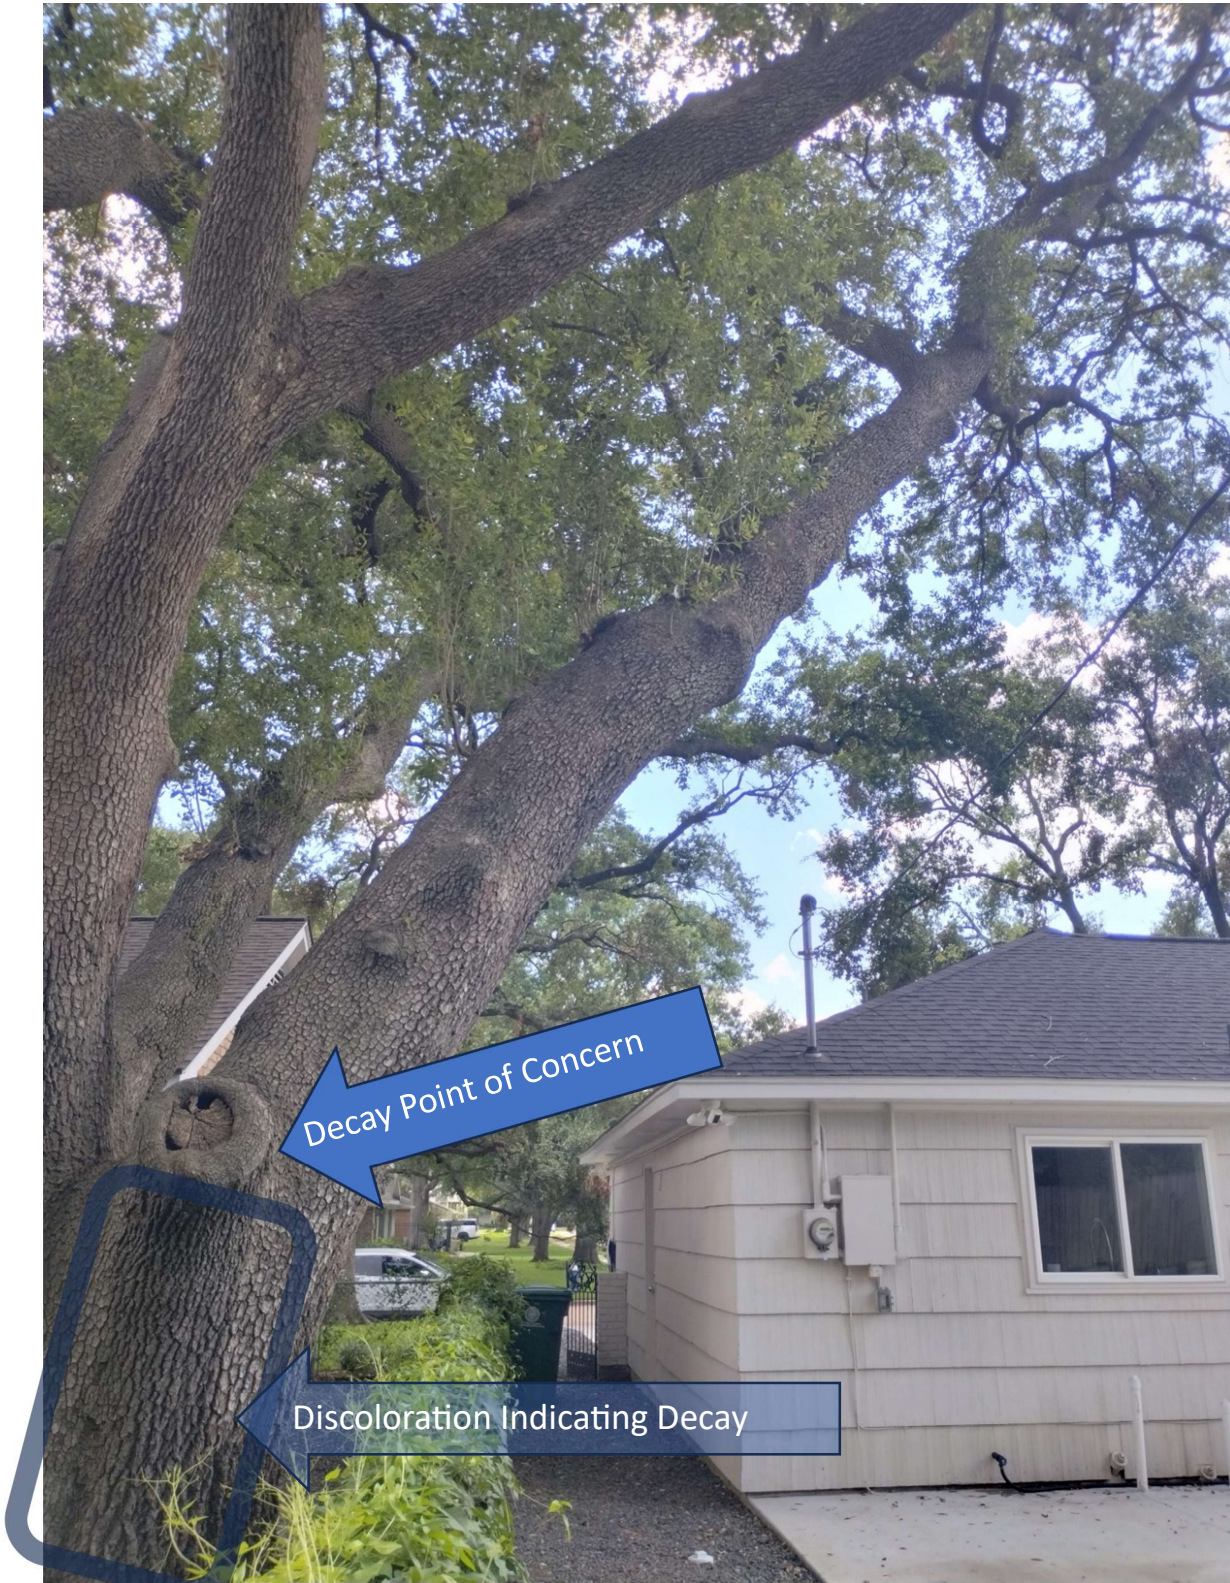
The length and weight of the limbs overhanging Mr. and Mrs. Jones' home increases the mechanical load on the attachment points, which, as mentioned before has some decay on the compression side at the base where it attaches to the trunk of the tree. In storm events, overextended limbs are more prone to failure due to increased leverage, as described in Gilman (2002), *An Illustrated Guide to Pruning*. Without intervention, such limbs can become more and more structurally hazardous over time, posing a serious risk to the Durbin's roof and potentially endangering the residents.

Figure 3 - Looking from back side of large primary branch overhanging roof. Note decay point and discoloration of woody support tissue on back side of lean.

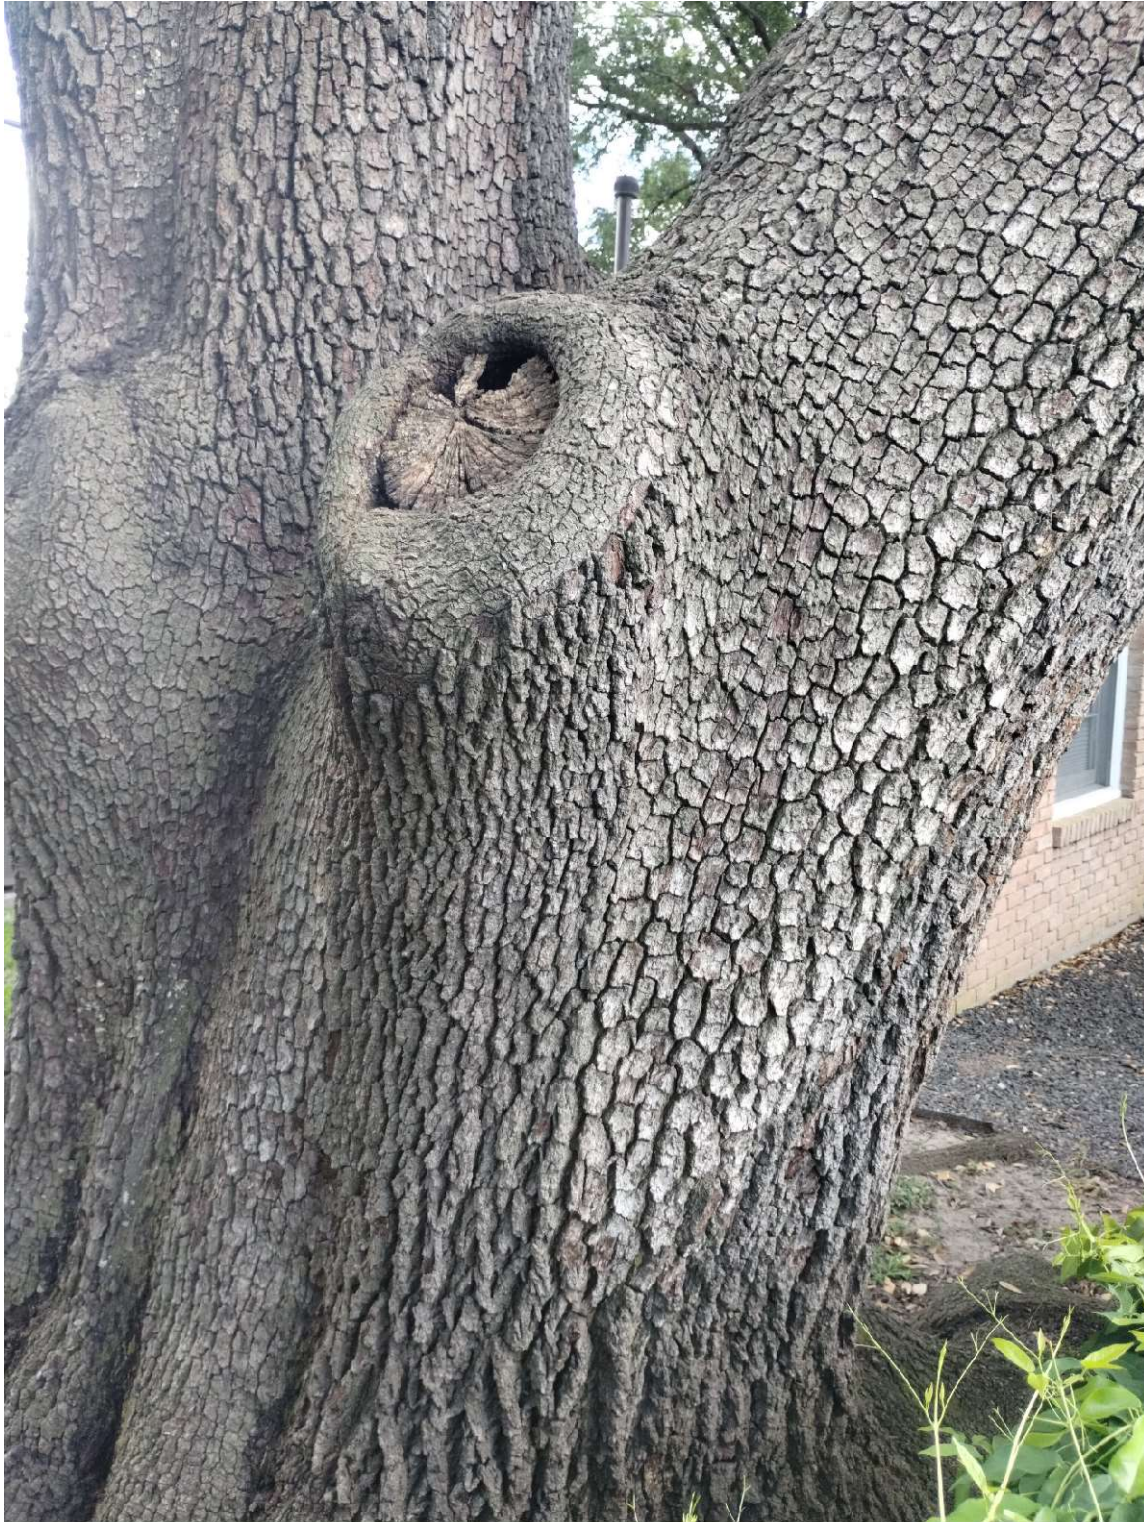
*Figure 4 - Closeup of Decay Point. Note how the limb is compartmentalizing, but not at a rate effective to completely close wound before internal tissue decays.*

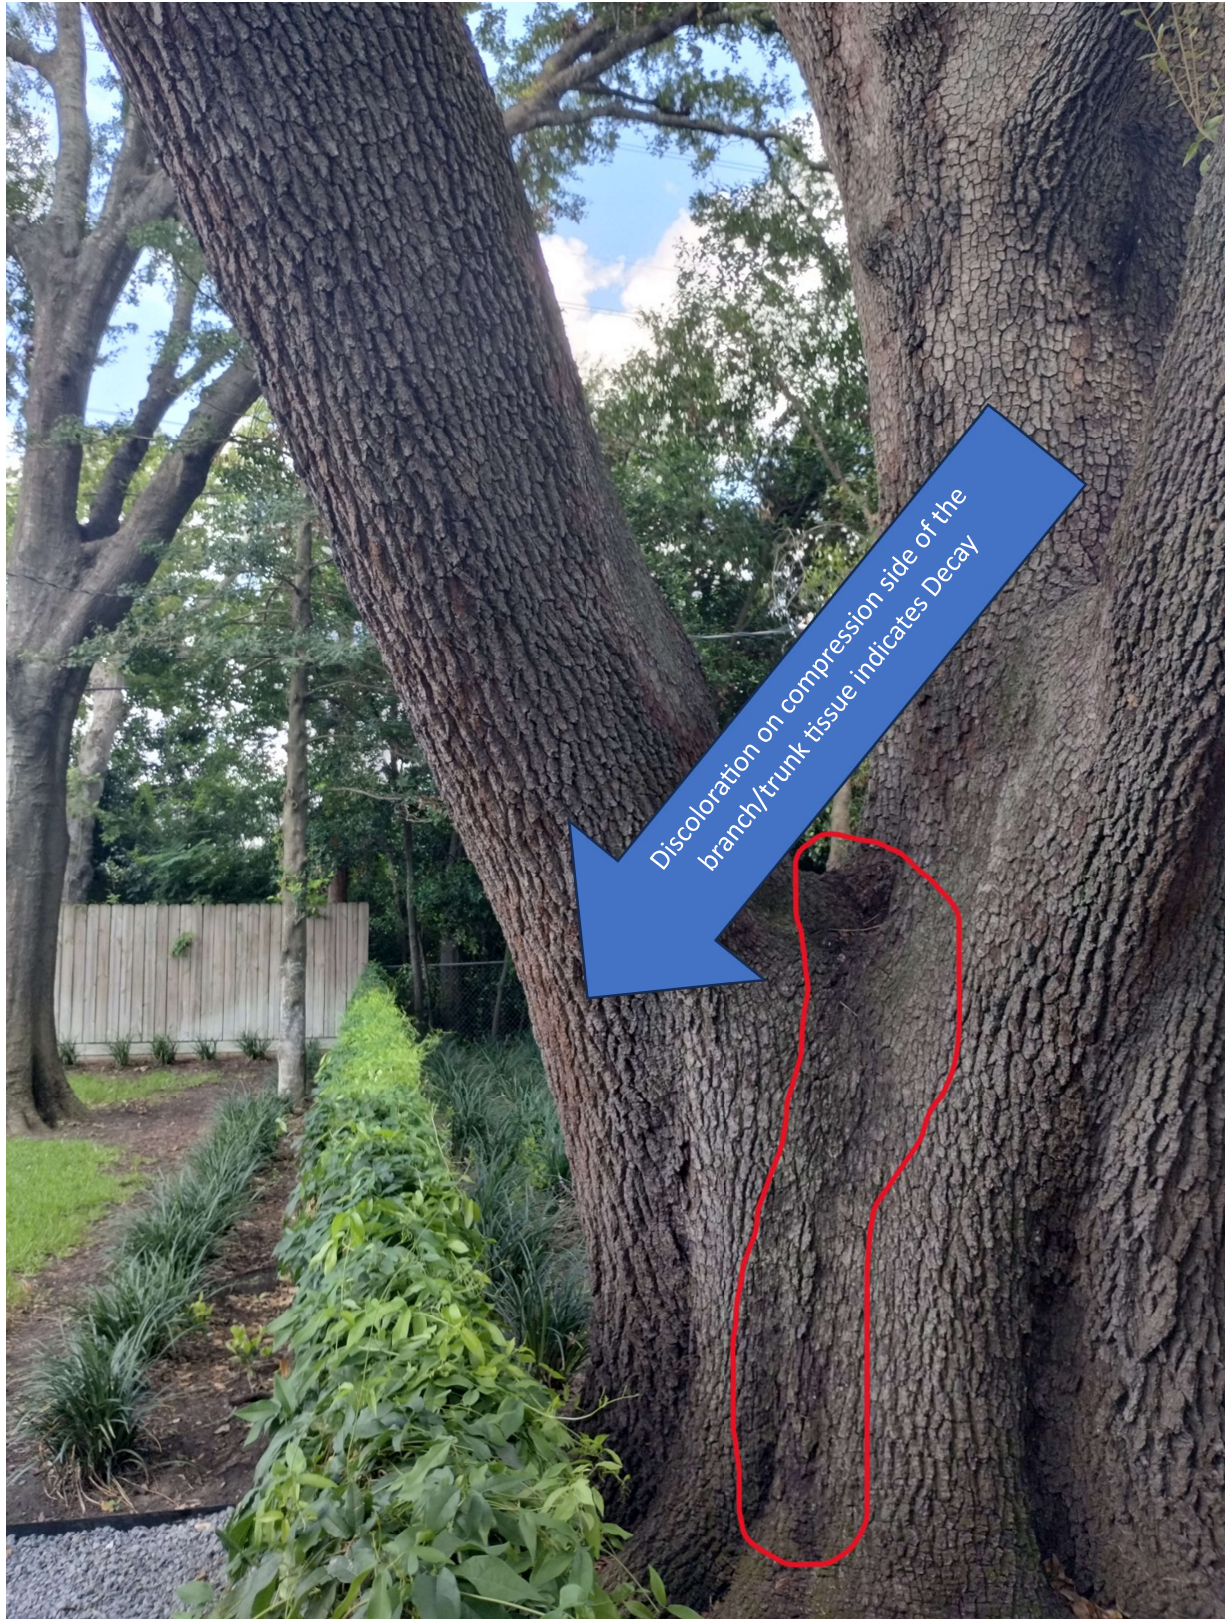
*Figure 5 - Base of the Attachment Point of the Limb in question - note the slight cavity and significant crack (branch/Bark Ridge). This is looking opposite the decay point at the base of the limb.*

3. Apply paclobutrazol tree growth regulator to slow outward growth and enhance the overall health and structural integrity of the wood.
4. Install two structural support cables from the limb to opposite parts of the canopy on the neighbor's side to provide additional support.

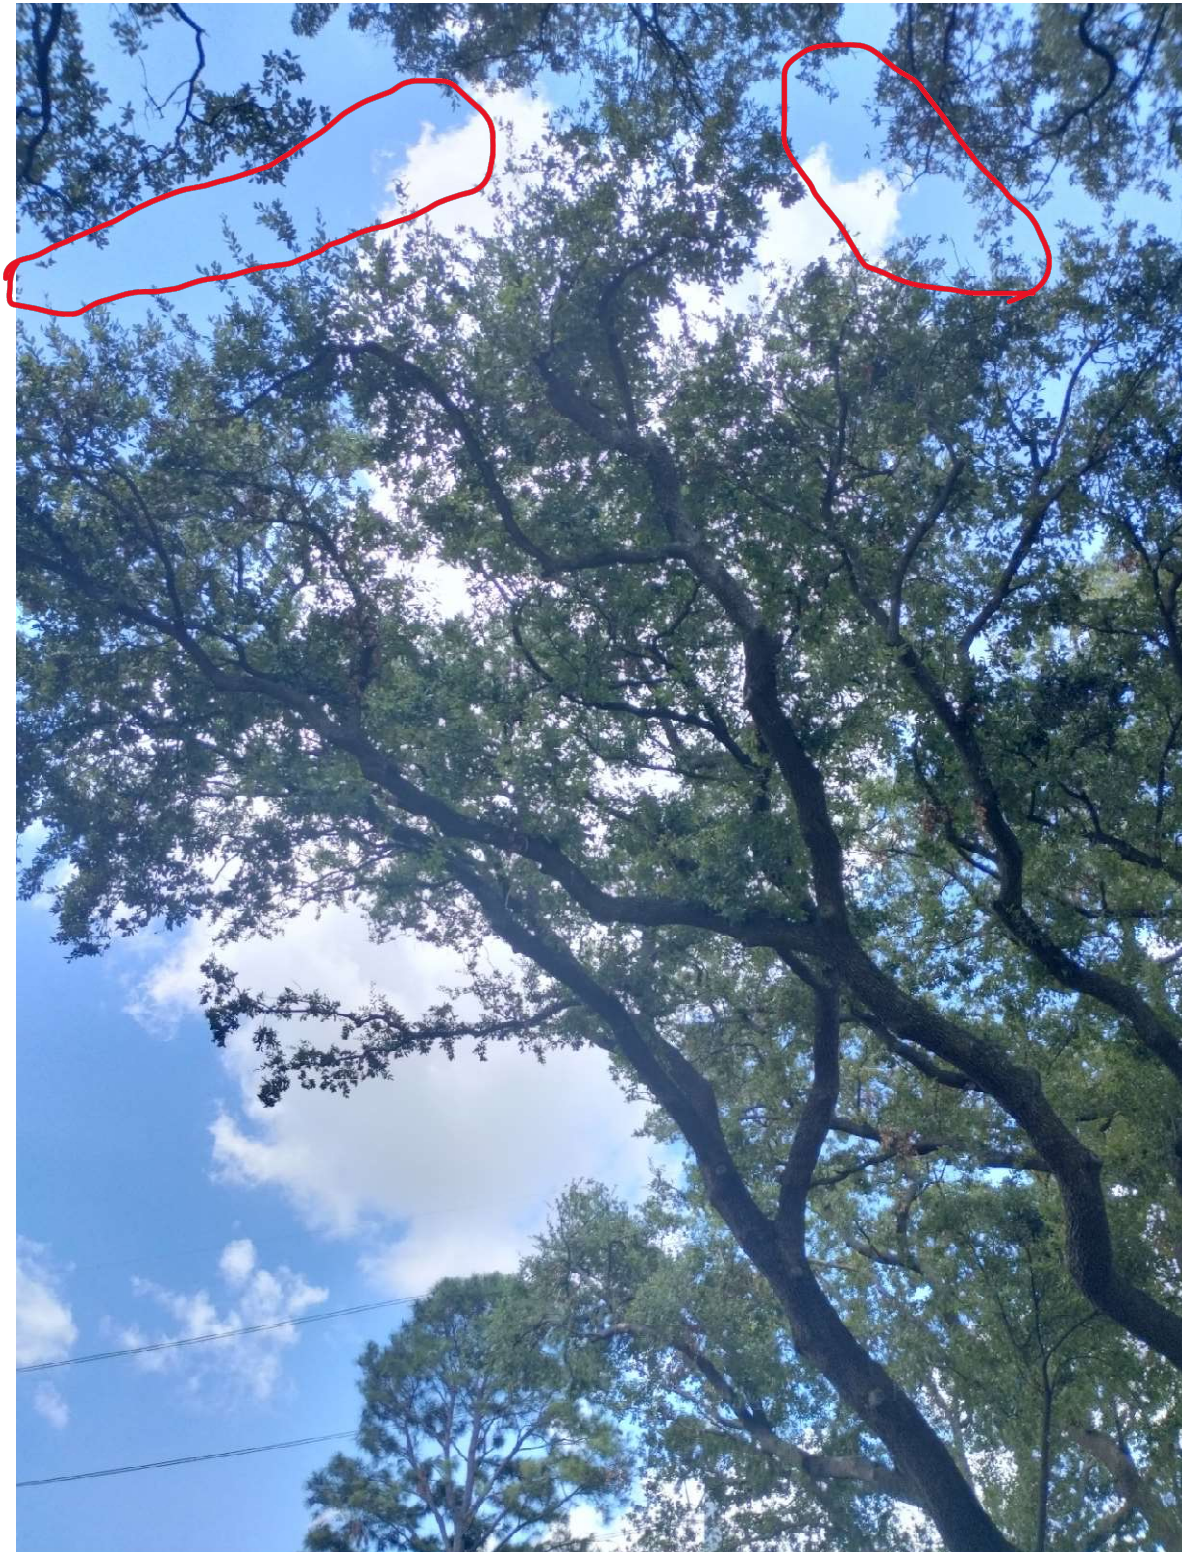
*Figure 6 - Limb in Question hanging over hanging Mr. and Mrs. Jones' home - note the separation in the upper canopy, indicating that there is too much weight for the limb to support*
